# CHALLIS AIRPORT

This report describes how your pavement maintenance management program was developed. This program was developed as part of the Network Pavement Management Program project sponsored by the Idaho Transportation Department, Division of Aeronautics. The information and data contained in this report ensures you are in compliance with the requirements of Federal Aviation Administration (FAA) Grant Assurance Number 11 which states that any airport requesting federal funds for pavement improvement projects must have implemented a pavement maintenance management program (PMMP).

Figure CH-1. Airport Layout, Dimensions and Pavement Cross-Sections.  
Challis Airport

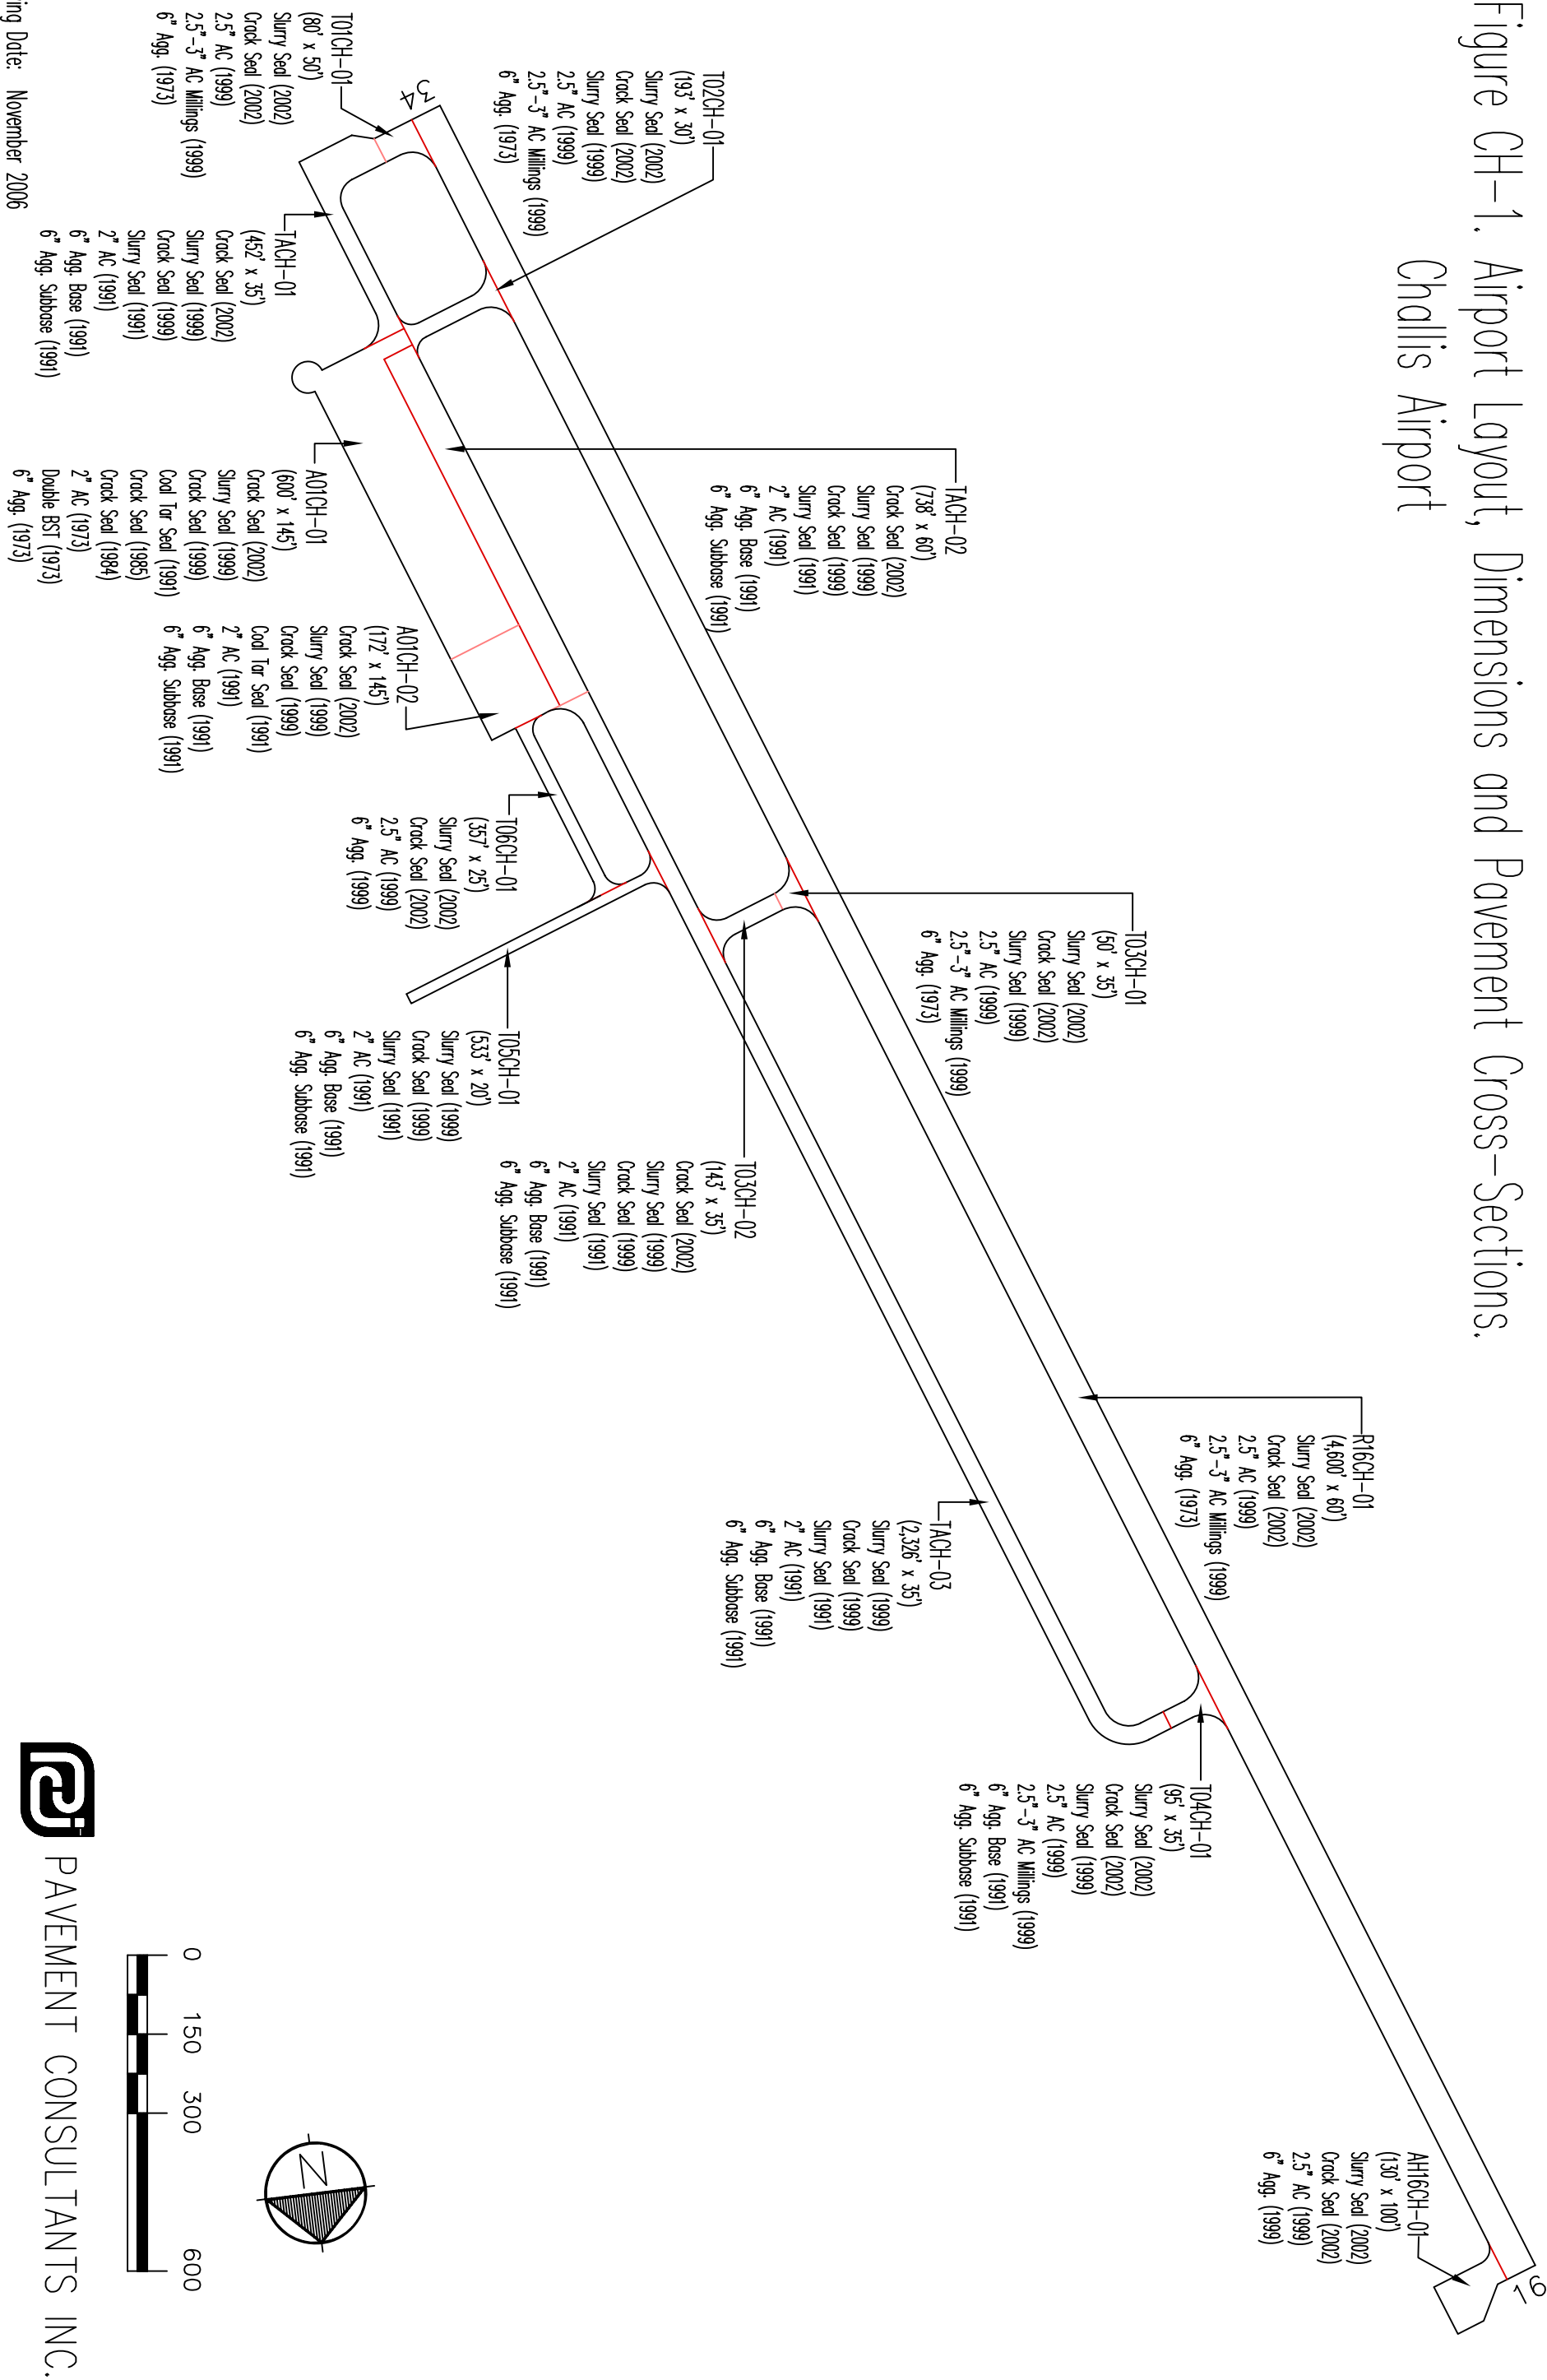
To determine how your pavements were constructed and their age, a records review was conducted. Figure CH-1 shows the records review results. This figure shows pavement boundaries, dimensions, pavement layer types, thicknesses and dates of construction. Table CH-1, provided in Appendix 1, contains the up-to-date cross-section information for each pavement section. The most recent construction date for each pavement can also be found in the Section Condition Report in Appendix 2. Figure CH-1, Table CH-1, and the information contained in Appendices 1 and 2 ensure that your airport complies with the “pavement inventory” requirement of FAA’s PMMP guidelines.

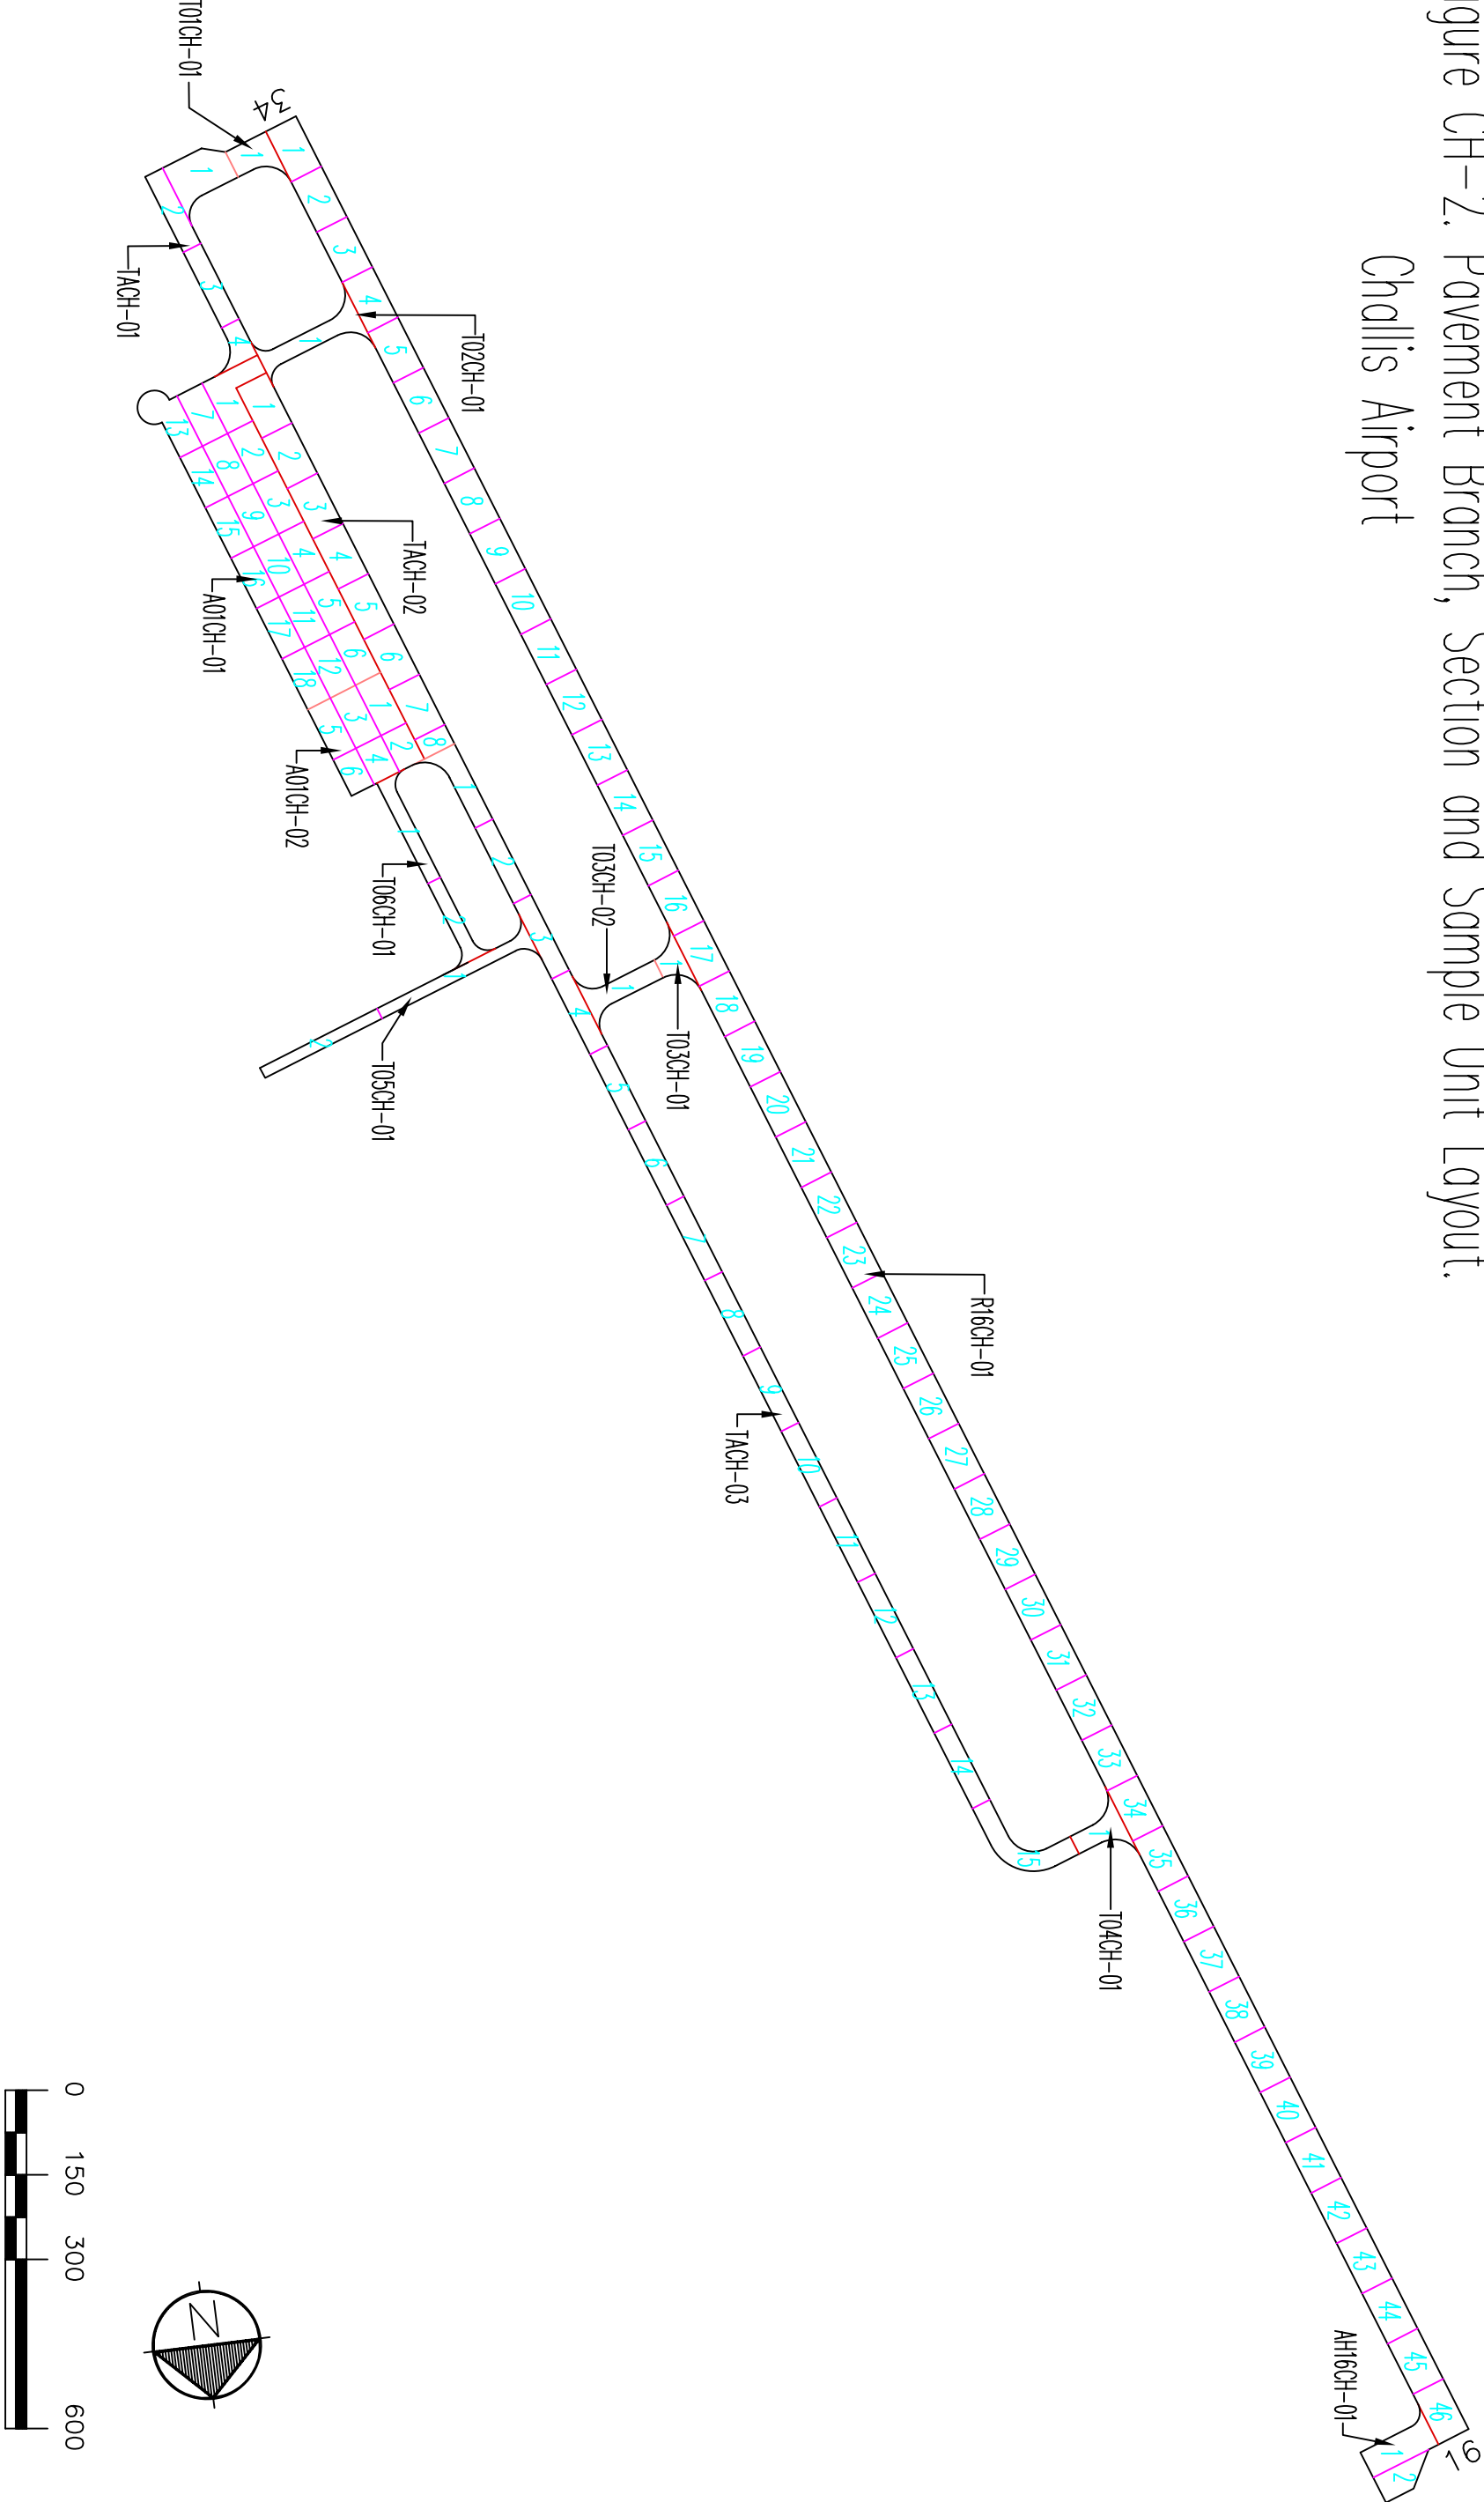
Figure CH-2. Pavement Branch, Section and Sample Unit Layout.  
Challis Airport

The pavements at your airport were divided into branches, sections and sample units in accordance with the methodology outlined in the current editions of FAA Advisory Circular AC:150/5380-6, *Guidelines and Procedures for Maintenance of Airport Pavements* and ASTM D5430, *Standard Test Method for Airport Condition Index Surveys*. The branches, sections and sample units established at your airport are shown in Figure CH-2. A Branch Condition Report showing all branches, their associated areas, and area-weighted average condition is provided in Appendix 2. Additionally, the Appendix 2 Section Condition Report provides information that the Micro PAVER pavement management software uses to define each branch and section.

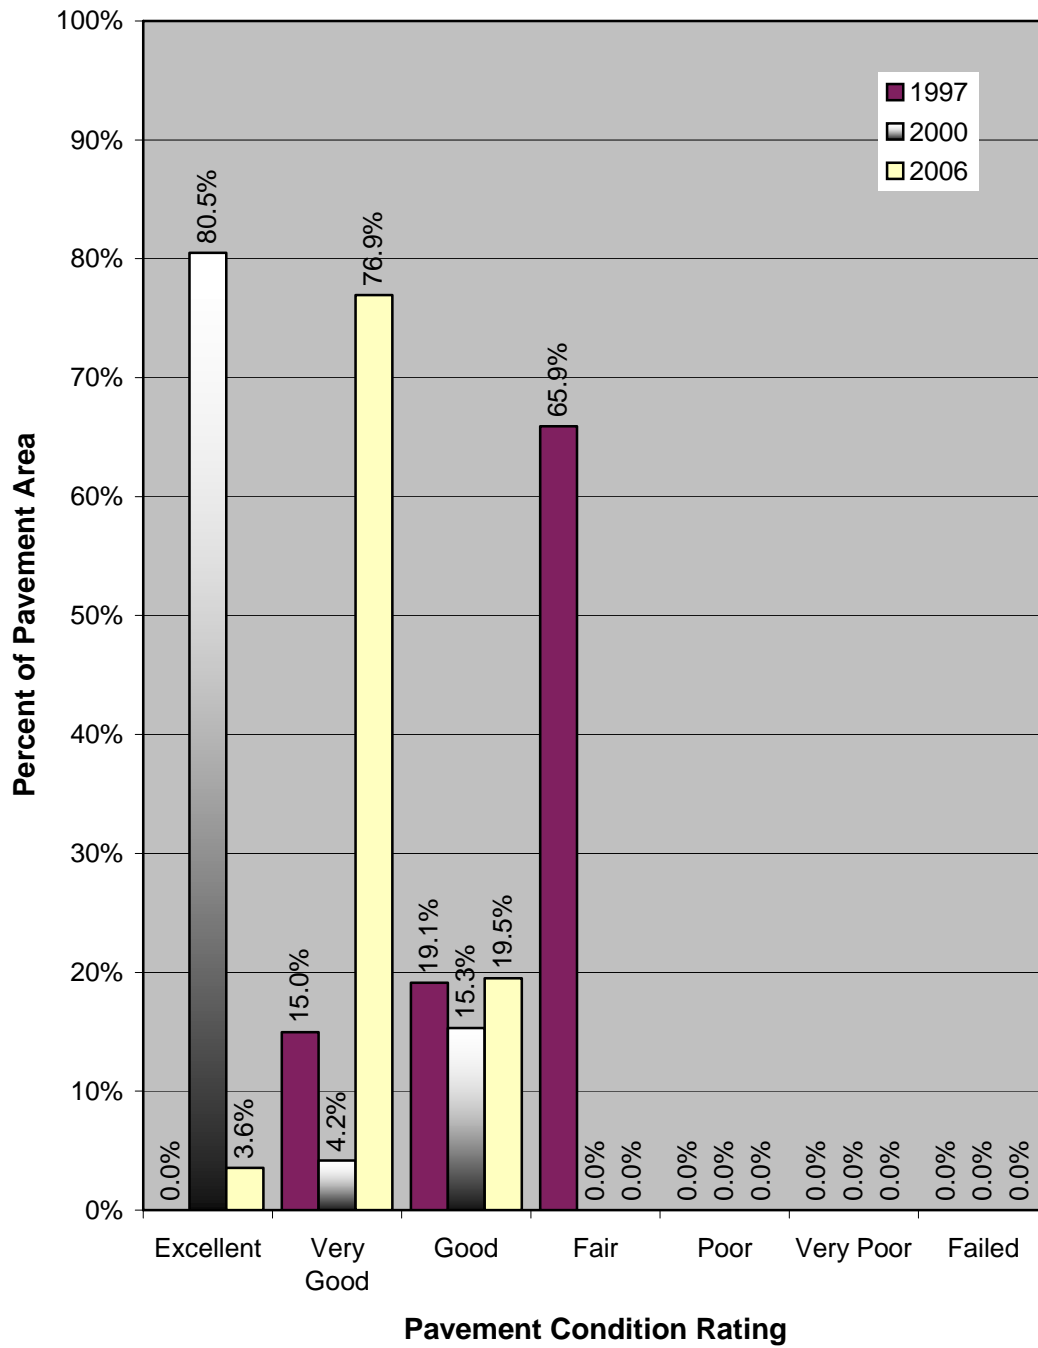
**Figure CH-4. Distribution of Pavement Condition  
Challis Airport**

Section PCIs at the airport range from a low of 58 (a PCR of "Good") to a high of 100 (a PCR of "Excellent"). The area-weighted average PCI for all airport pavements is 76, corresponding to an overall PCR of "Very Good". Figure CH-4 shows how much pavement area is associated with each Pavement Condition Rating category and also shows pavement condition distribution from the inspections conducted in 1997 and 2000. A graphical representation of the projected PCRs presented in Table CH-2 is shown in Figure CH-5.
